**EVALUATION OF NON-DESTRUCTIVE TECHNIQUES FOR
CORROSION DETECTION IN CONCRETE EXPOSED
TO A MARINE ENVIRONMENT**

**Prepared in cooperation with the State of Hawaii Department of Transportation,
Highways Division and U.S. Department of Transportation, Federal Highway
Administration**

Research Report UHM/CEE/05-04

May 2005

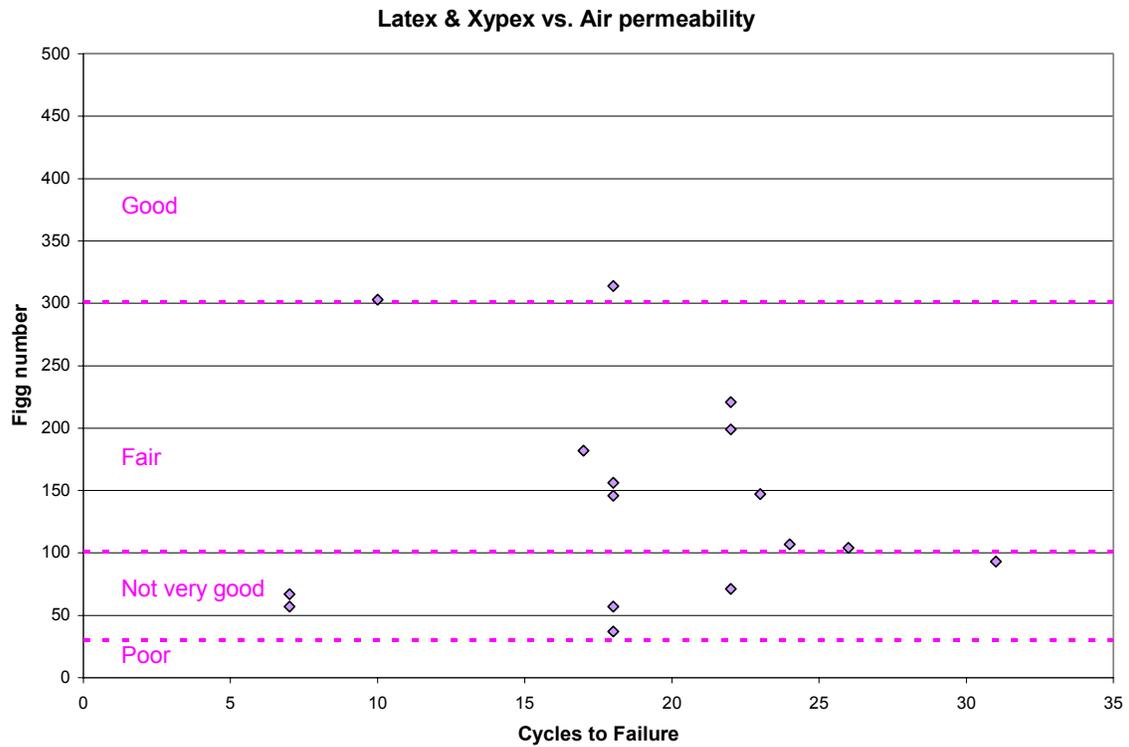
Figure 6.7 : Latex & Xypex – Air permeability

Figure 6.7 plots the Figg number of the Latex and Xypex admixtures versus the number of cycles to failure. There is no apparent correlation between permeability and cycles to failure for these specimens.

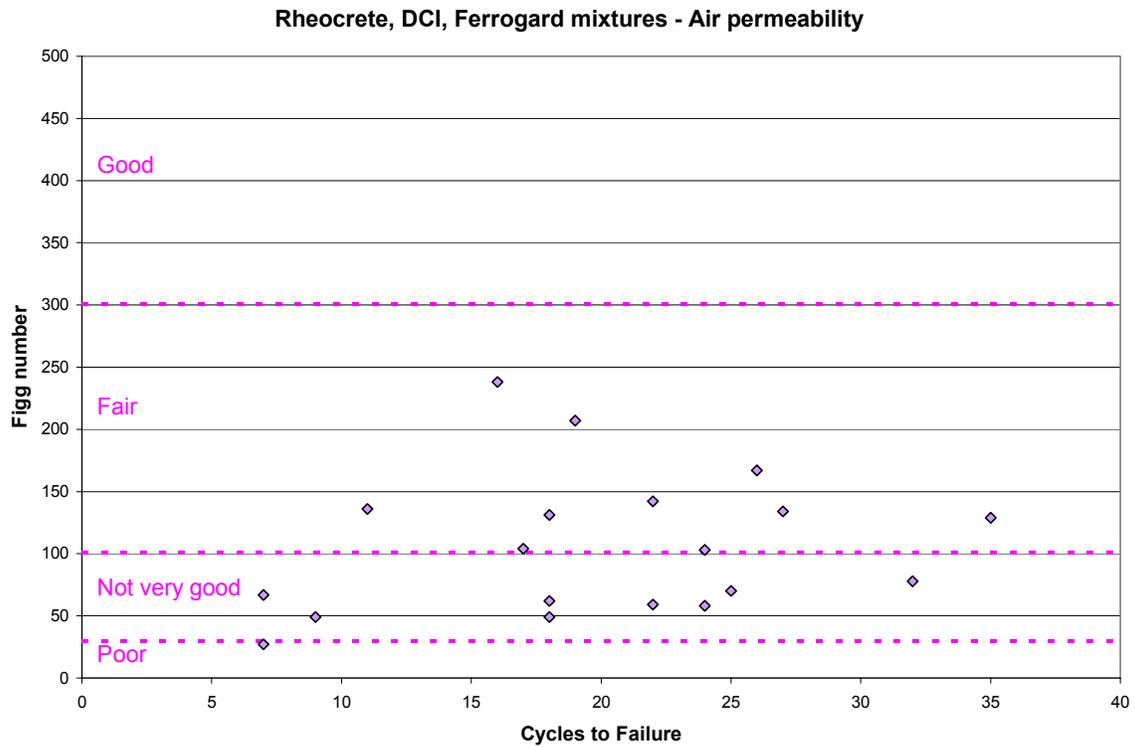
Figure 6.8 : Rheocrete, DCI, Ferrogard – Air permeability

Figure 6.8 plots Rheocrete, DCI, and Ferrogard mixture Figg numbers versus the number of cycles to failure. The graph shows a weak trend of a higher Figg number (less permeability) relating to a greater number of cycles until first corrosion. The trend is one that would be expected but it is also a weak correlation.

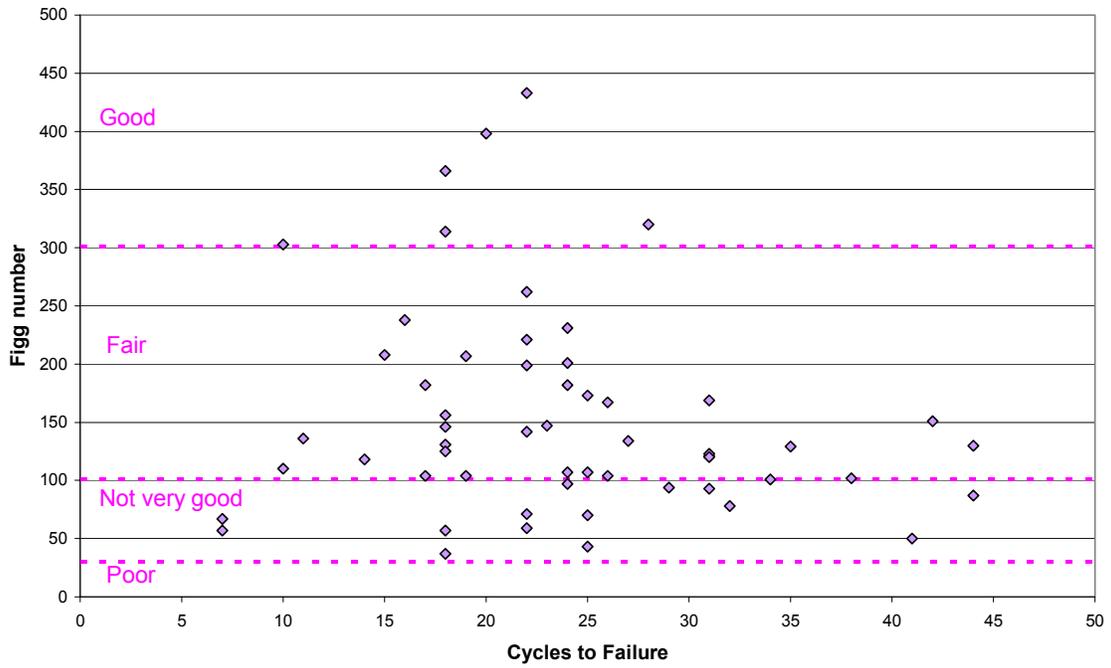
Figure 6.9 : All Ameron mixtures – Air permeability

Figure 6.9 shows all the Ameron mixtures Figg numbers versus cycles to failure. Figure 6.10 shows all the Halawa mixtures Figg numbers versus cycles to failure. The cumulative results do not indicate any trend. The Halawa aggregate are more permeable than the Ameron aggregate.

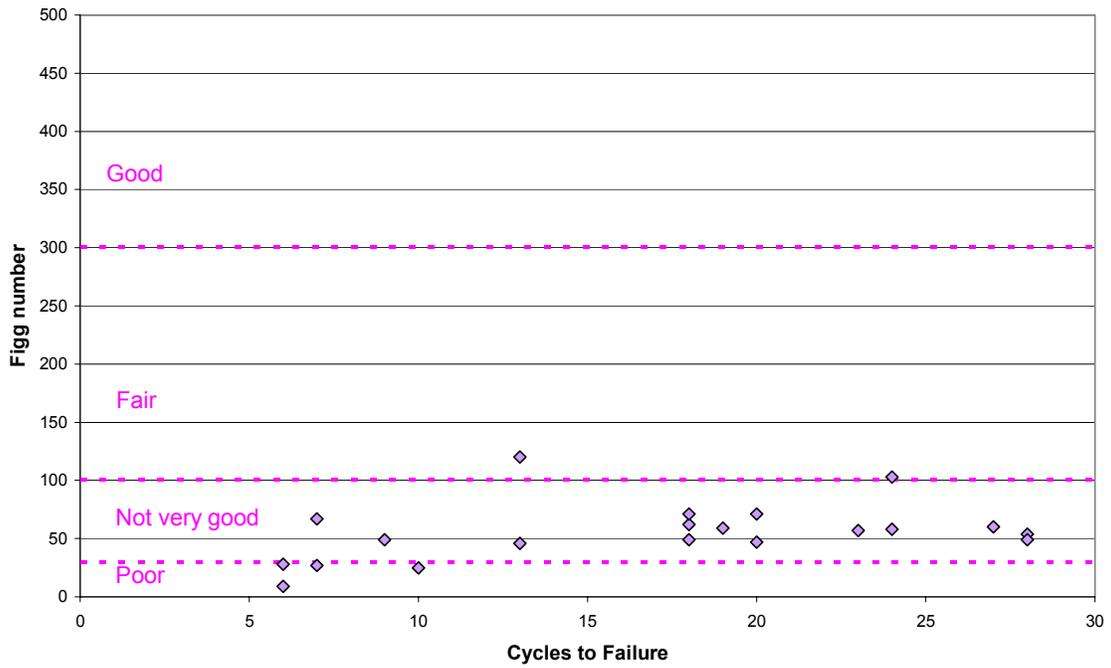
Figure 6.10 : All Halawa Mixtures – Air permeability

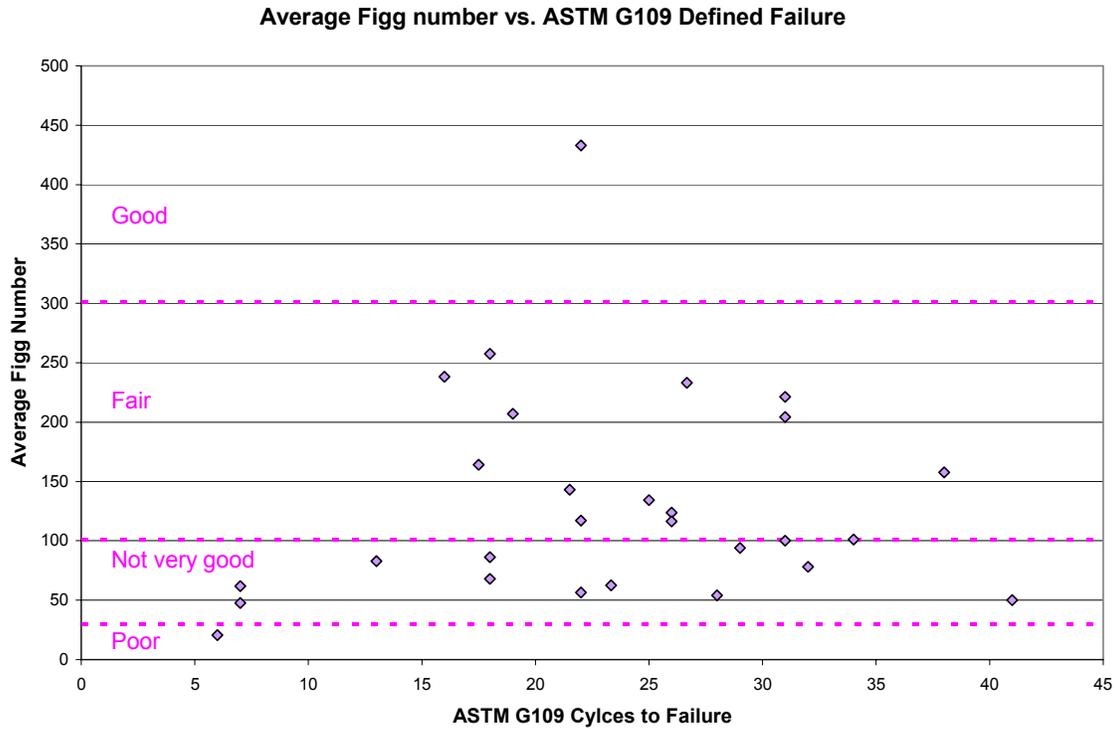
Figure 6.11 : Average Figg numbers vs. ASTM G109 Cycles to Failure

Figure 6.11 shows the average Figg numbers versus the ASTM G109 cycles to failure. The mixes with multiple specimens that failed were all averaged. The figure incorporates all of the admixtures. The averaged results do not indicate any trend or conclusion.

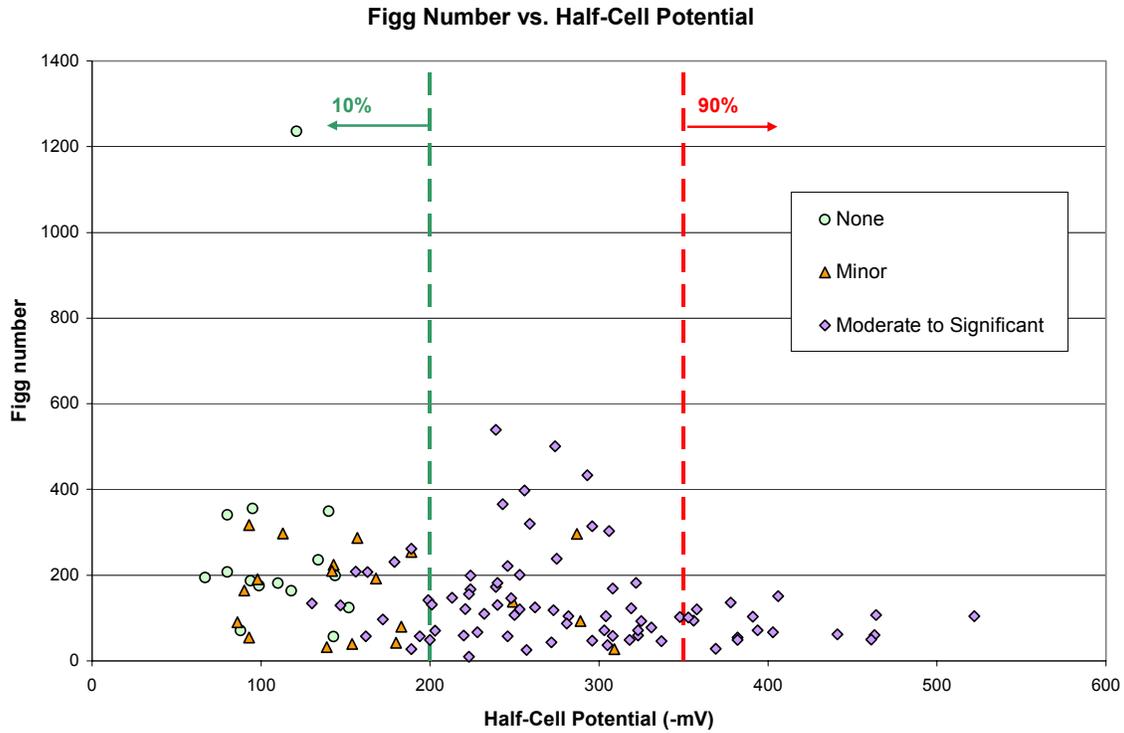
Figure 6.12 : Figg number vs. Half-cell potential

Figure 6.12 shows the relationship between Figg number and half-cell potential for all specimens in this study. The degree of corrosion observed in each specimen is indicated by the symbol color. Permeability relates to corrosion because high permeability increases the ability of chlorides to attack the reinforcing steel. Figure 6.12 does not show any clear correlation between the Figg number and the half-cell potential.

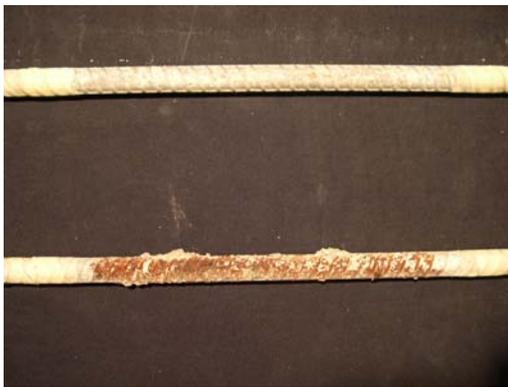
Figure 7.3- Bars, bottom

Con1 #1 – The visual inspection did not show much on the outside. On the inside of the right bar it was almost completely covered with corrosion on the bottom. The top of the bar had a few areas of corrosion. The left bar has a pits on the bottom of the bar. The half cell potential results all fell into the uncertain range. The voltage readings show the specimen had failed. The inspection concluded the corrosion to be moderate to significant.

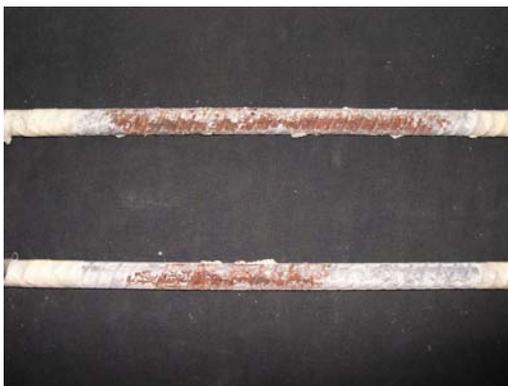
Figure 7.7 - Bars, bottom

Con1 #2 – The outside of the specimen looked to be in good condition. On the inside there was significant corrosion on the bottoms of both bars. The tops of both of the bars had very few discolorations. The half cells potential readings indicate that all the reading were in the uncertain range. The voltage readings illustrate that the specimen had not yet reached failure mode. The inspection concluded the corrosion to be moderate to significant.

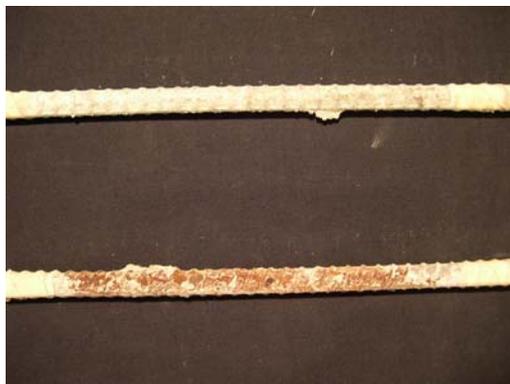
Figure 7.11 - Bars, bottom

Con1 #3 – The visual inspection showed a few cracks on the right side on both the top surface and the side surface. The cracks mostly above the right bar, there was also a small crack in the middle of the specimen. All of the corrosion inside the specimen was located on the right bar. The bottom of the right bar was covered in hazy corrosion while the top of the bar has a smaller area of corrosion it was more concentrated and darker in color. The half cell potential readings show that all of the values were in the uncertain range. The voltage readings show that the specimen has reached the failure mode. The inspection concluded the corrosion to be moderate to significant.

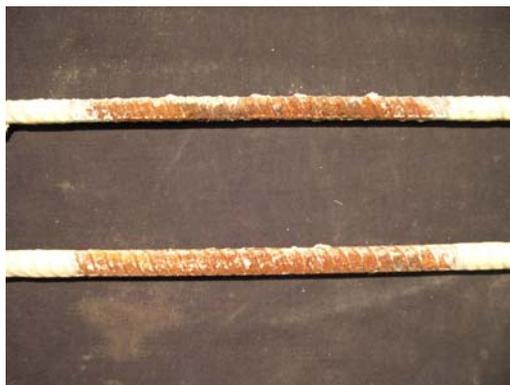
Figure 7.15 - Bars, bottom

Con1 #4 – The visual inspection showed the specimen was in good condition. In the inside of the specimen both bars were completely covered on the bottoms. The top of the bars had some corrosion areas scattered along the edges. The half cell potential values show that all of the values fell into the 10% of probability range. The voltage numbers indicated that the specimen had reached failure. The inspection concluded the corrosion to be moderate to significant.

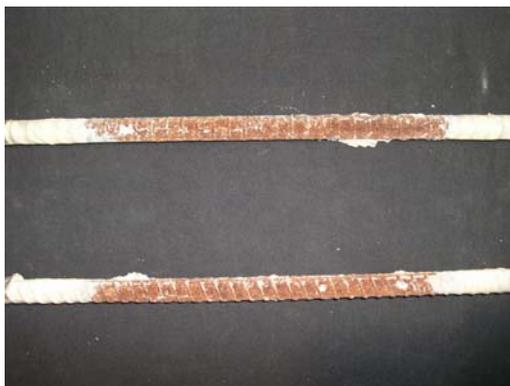
Figure 7.19 - Bars, bottom

Con1 #7 – The visual inspection did not show any major flaws in the specimen. The inside of the specimen had lots of corrosion on the bottom of both bars. The bottoms of both bars are almost completely covered with the tops having some corrosion along the edges. The half cell potential readings indicate that all of the values fell into the uncertain range. The voltage results show that the specimen was not close to failure. The inspection concluded the corrosion to be moderate to significant.

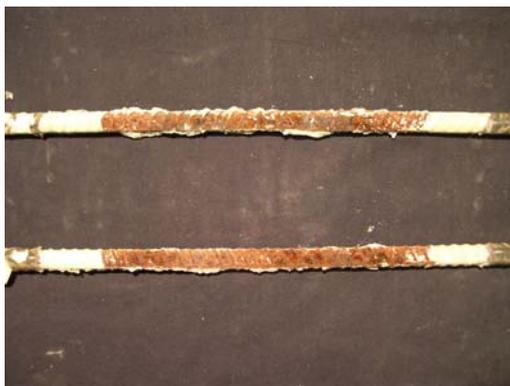
Figure 7.23 - Bars, bottom

Con2 #2 – The visual inspection did not provide any useful additional information. The inside of the specimen showed multiple areas of corrosion. The bottoms of both bars were completely covered in corrosion. The tops of the bars had multiple corrosion spots. The half cell potential numbers show that all of the values were in the uncertain range. The voltage readings show that the specimen had failed. The inspection concluded the corrosion to be moderate to significant.

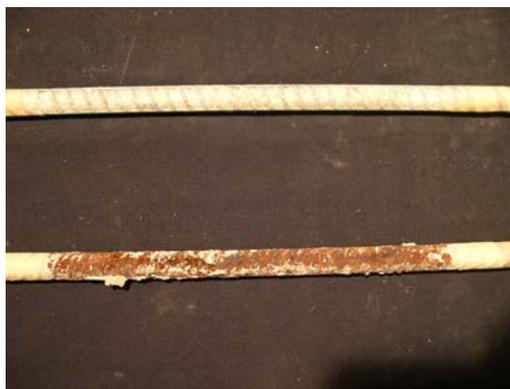
Figure 7.27 - Bars, bottom

Con2 #3 – The specimen looked in good condition from the outside. On the inside the majority of the corrosion was located on the bottom of the right bar. On the top of the right bar there were multiple black and silver pits. The left bar had a few pits on the bottom. The half cell potential values all fell into the uncertain range. The voltage readings show that the specimen had failed. The inspection concluded the corrosion to be moderate to significant.

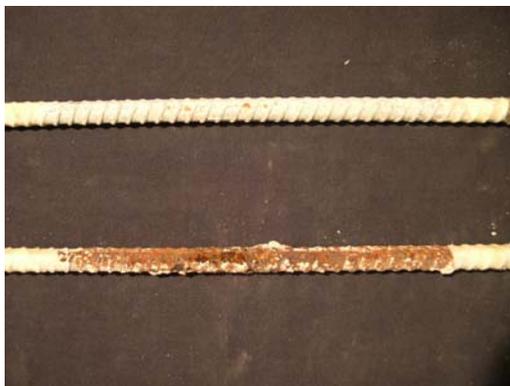
Figure 7.31 - Bars, bottom

Con2 #5 – The visual inspection did not show any major cracks or voids on the outside. On the inside the majority of the corrosion was located on the bottom of the right bar. The right bar also had some spots on the top. The left bar had some pits on the bottom. The half cell potential numbers show that all of the values fell into the uncertain range. The voltage readings show that the specimen was considered to be failed. The inspection concluded the corrosion to be moderate to significant.

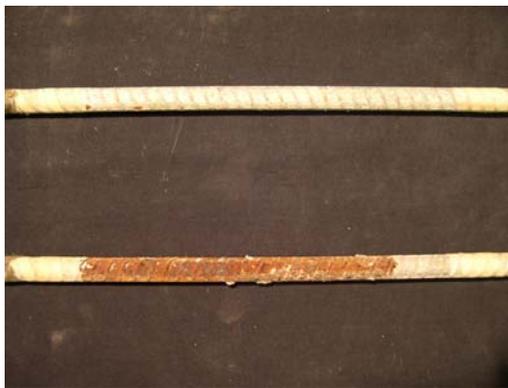
Figure 7.35 - Bars, bottom

Con2 #6 – The visual inspection of the outside of the specimen showed that there were no major flaws. The inside of the specimen contained corrosion on the bottom of the right bar. The right bar was completely covered in corrosion and the top had a few spots. The bottom of the left bar had pits along the length of the bar. The half cell potential numbers all fell into the uncertain range. The voltage results show that the specimen was not close to being considered as a failure. The inspection concluded the corrosion to be moderate to significant.

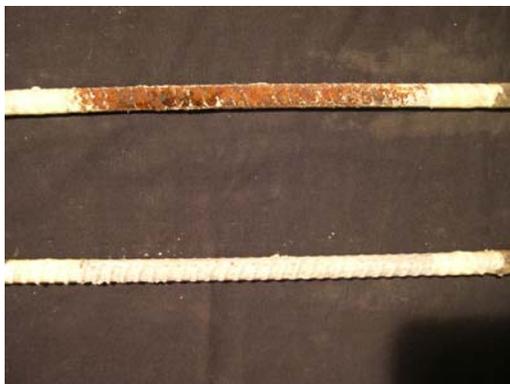
Figure 7.39 - Bars, bottom

Con2 #7 – From the outside the specimen looked very clean. From the inside the bottom of the left bar was covered in corrosion. The top of the left bar had some black and silver spots on the edges. The right bar had multiple pits and spots on the bottom. The half cell potential values were found in the range of uncertain. The voltage readings show that the specimen was getting close to the failure threshold. The inspection concluded the corrosion to be moderate to significant.

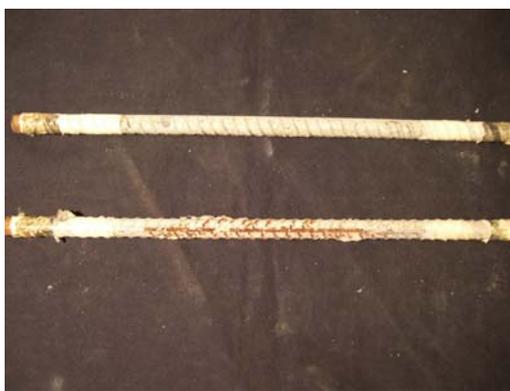
Figure 7.43 - Bars, bottom

Con3 #5 – The visual inspection showed a crack on the top surface. The crack is in the middle but more to the right than left. There was also a long crack along the right side that was parallel to the right reinforcement. On the inside of the specimen the majority of the corrosion was located on the right bar. The corrosion on the bottom covers the ribs of the steel, while the corrosion on the top is a concentrated black area. The half cell potential values were all in the 90% probability range. The right side values were much higher than the left side. The voltage readings show that the specimen had reached failure. The inspection concluded the corrosion to be moderate to significant.

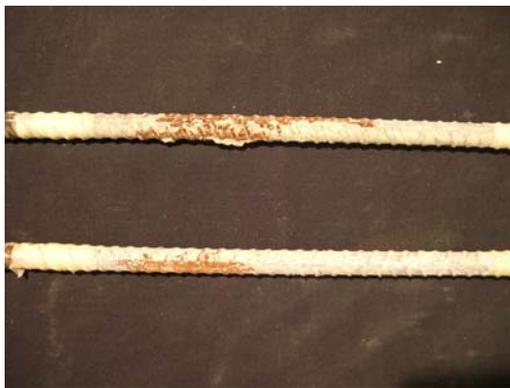
Figure 7.47 - Bars, bottom

Con3 #6 – The visual inspection of the specimen showed no major flaws on the outside. On the inside of the specimen the bottoms of both bars had some corrosion more towards the front of the bar. The left bar has more corrosion on the bottom and has a few spots on the top. The half cell potential numbers show that all of the values fell into the uncertain range, but the numbers on the right side was higher than the left side. The voltage results show that the specimen had not failed. The inspection concluded the corrosion to be moderate to significant.

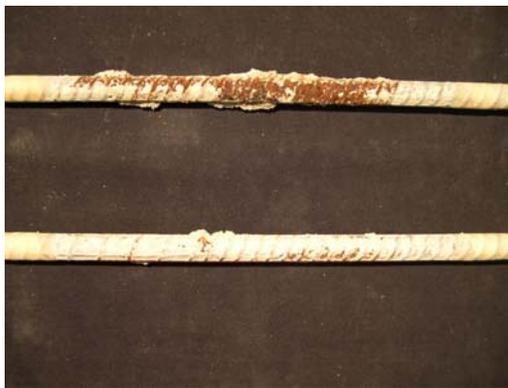
Figure 7.51 - Bars, bottom

Con4 #1 – The visual inspection showed multiple cracks above the left bar. The cracks spanned parallel to the left reinforcement on the top surface and on the left side. There was also a crack in the middle of the specimen and two small cracks on the right side. On the inside of the specimen there was lots of corrosion on both bars. The left bar has more corrosion on the top and bottom than the right bar. The right bar had corrosion on the edges. The half cell potential readings showed all the values in the uncertain range. The voltage readings showed that the specimen reached the failure. The inspection concluded the corrosion to be moderate to significant.

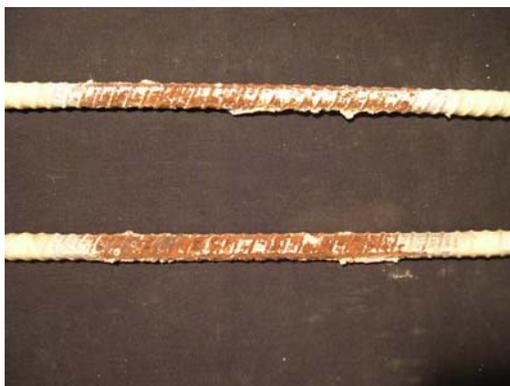
Figure 7.55 - Bars, bottom

Con4 #2 – The visual inspection showed that there were cracks on the right side on the top and side surface. On the inside of the surface both bars looked bad. Both bars were almost covered on the bottom and had some scattered areas on the top. According to the half cell potential readings all fell into the uncertain category. The voltage readings show that the specimen had reached failure. The inspection concluded the corrosion to be moderate to significant.

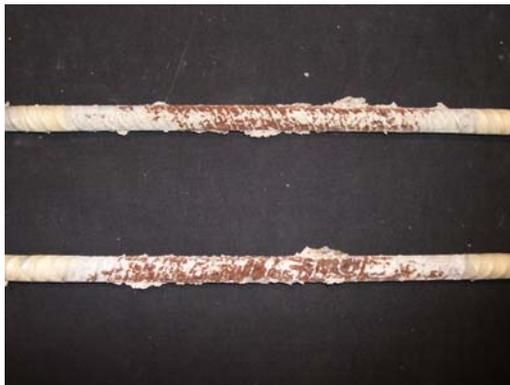
Figure 7.59 - Bars, bottom

Con4 #3 – The visual inspection showed that there were no major flaws on the outside of the specimen. On the inside of the specimen both bars were well covered in corrosion on both top and bottom of the bars. The half cell potential results show that all the values were in the uncertain range. The voltage readings showed the specimen had reached the failure threshold. The inspection concluded the corrosion to be moderate to significant.

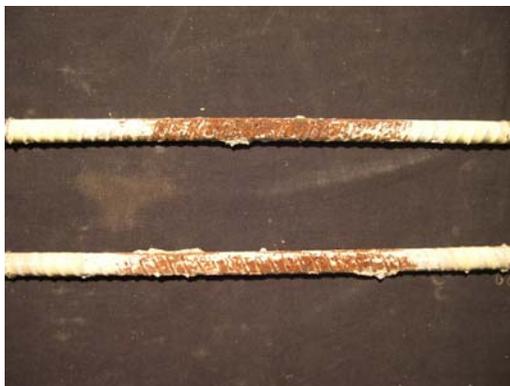
Figure 7.63 - Bars, bottom

Con4 #4 – The visual inspection did not show any cracks, but it did show some light brown discolorations on the top surface above the left reinforcement. Both reinforcement bars were well covered on their bottoms with corrosion. The tops of the bars had areas of scattered corrosion with some pits. The half cell potential numbers indicate that all the values fell into the 10% probability of corrosion range. The voltage readings showed the specimen had reached failure. The inspection concluded the corrosion to be moderate to significant.

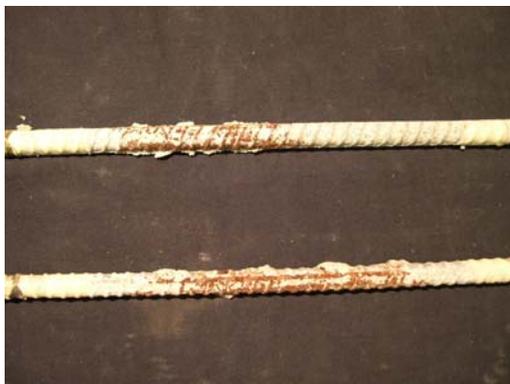
Figure 7.67 - Bars, bottom

Con4 #6 – The visual inspection on the outside of the specimen showed no critical flaws. There were some brown concentrations on the top surface on the left side. There was corrosion on both bars on the top and bottom. The corrosion on the right bar was more extensive than the left side. The half cell potential readings showed that the values on the left fell into the uncertain range, while the values on the right side all fell into the 10% probability range. The voltage reveals that the specimen had reached failure. The inspection concluded the corrosion to be moderate to significant.

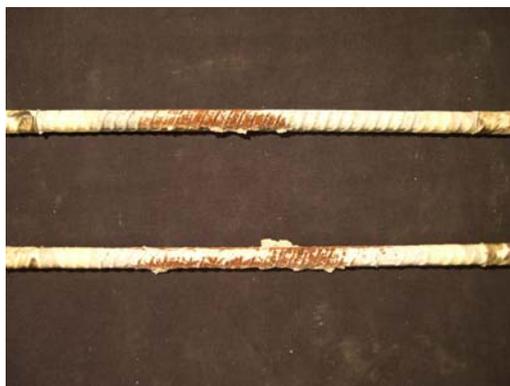
Figure 7.71 - Bars, bottom

Con4 #7 – Overall the visual inspection of the outside showed no major flaws. The examination of the bars showed that there was corrosion on both bars. The corrosion on the bottom of both bars was more concentrated than the corrosion located on the top. The half cell potential tests reveal that all the numbers fell into the uncertain range. The voltage readings showed that the specimen had reached failure. The inspection concluded the corrosion to be moderate to significant.

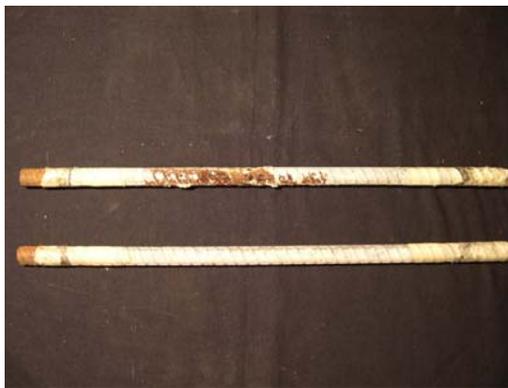
Figure 7.75 - Bars, bottom

DCI1 #2 – The outside of the specimen appears to be in good condition. There is one small void on the top surface that was toward the front and to the left. The majority of the corrosion appears on the bottom of the left bar. The top of the left bar has a couple of pits. The bottom of the right bar has some pits as well. The half cell potential values all fell into the 10% probability range. The voltage data showed that the specimen was close to failure but did not reach that point. The inspection concluded the corrosion to be moderate to significant.

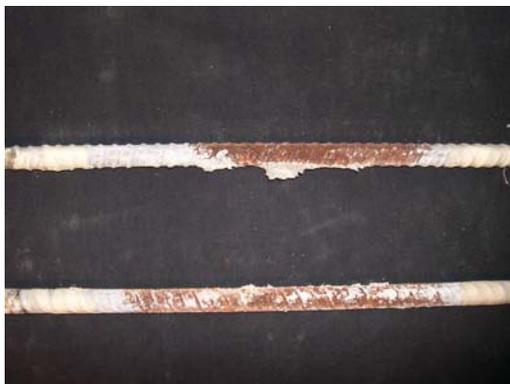
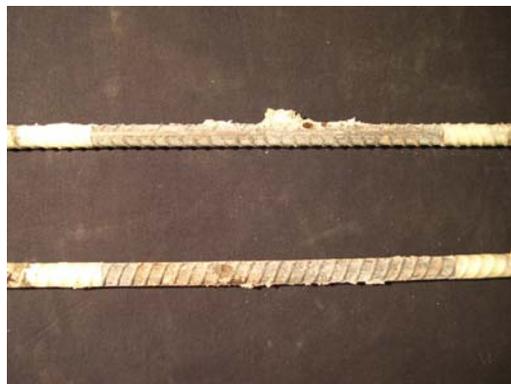
Figure 7.79 - Bars, bottom

DCI1 #6 – From the outside the specimen looked in great condition. Both bars are well covered in corrosion on their bottoms. The bottom of the right bar covers more area on the bottom than the left. On the top both bars had pits and other scattered areas of corrosion. The half cell potential values showed that left side had two numbers in the uncertain range. All the other values fell into the 10% probability range. The voltage results showed the specimen had failed. The inspection concluded the corrosion to be moderate to significant.

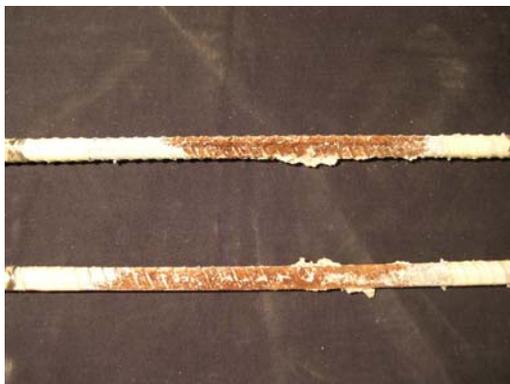
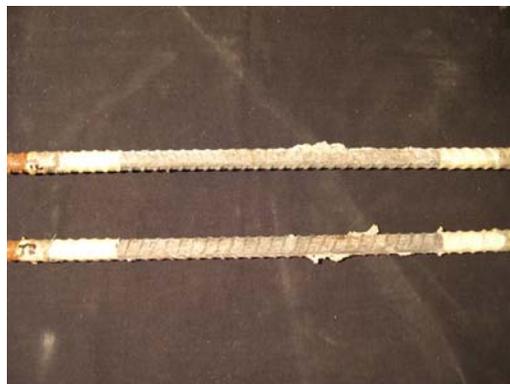
Figure 7.83 - Bars, bottom

DCI1 #8 – The visual inspection showed no detrimental flaws to the specimen. Both bars are well covered in corrosion on their bottoms. The bottom of the right bar covers more area on the bottom than the left. On the top both bars had pits and other scattered areas of corrosion. The half cell potential values on the left side and one on the right fell into the uncertain range. The other two values fell into the 10% probability range. The voltage data showed that the specimen had not failed, but was getting close. The inspection concluded the corrosion to be moderate to significant.

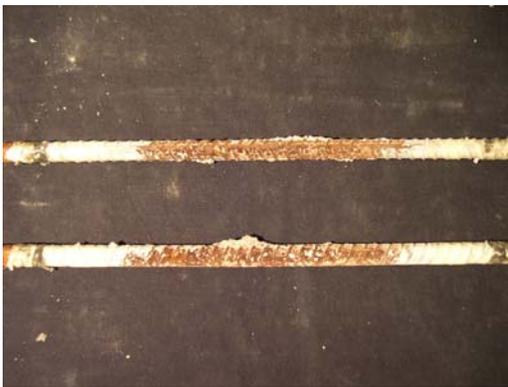
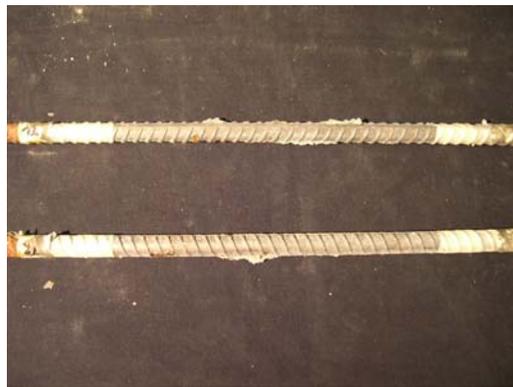
Figure 7.87 - Bars, bottom

DCI2 #4 – From the outside the specimen showed no discernable problems. The bottoms of both bars were well covered in corrosion. There were a large amount of voids that may have contributed to the corrosion. The tops of the bars had pits and spots on the edges. The half cell potential values all fell into the uncertain range. The voltage readings showed the specimen was very close to failure but it did not reach the failure threshold. The inspection concluded the corrosion to be moderate to significant.

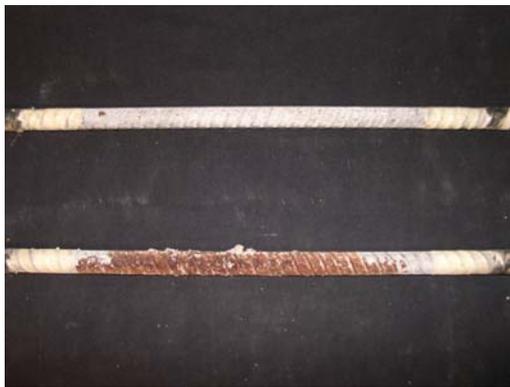
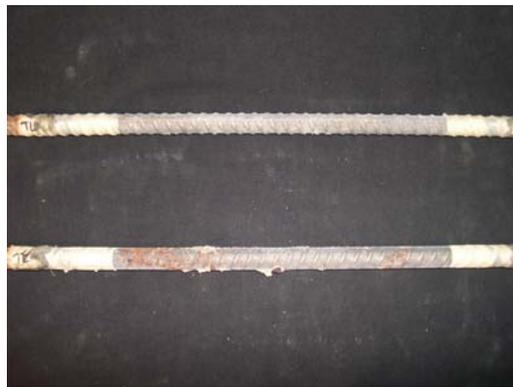
Figure 7.91 - Bars, bottom

DCI2 #8 – The visual inspection showed no major flaws on the outside. The right bar was well covered in corrosion on the bottom. The top of the right bar has a 2 inch area of corrosion near the front with pits toward the back. The left bar has pits on the bottom along the length of the bar. The half cell potential values all fell into the 10% probability range. The voltage data showed that the specimen had not failed. The inspection concluded the corrosion to be moderate to significant.

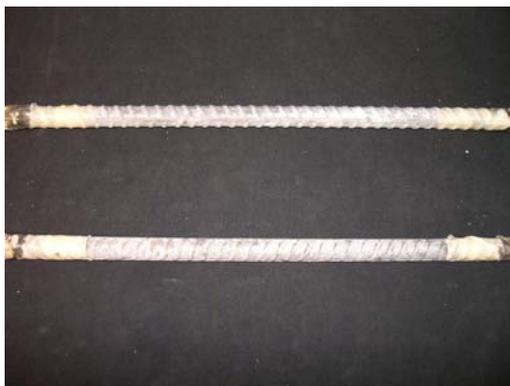
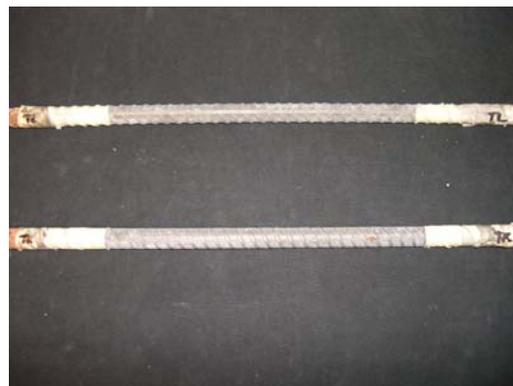
Figure 7.95 - Bars, bottom

DCI3 #8 – The visual inspection showed that the specimen was in good condition. The inside of the specimen was fairly clean. There were some spots here and there. The half cell potential values all fell into the 10% probability range. The voltage readings showed that the specimen had not failed. The inspection concluded the corrosion to be none.

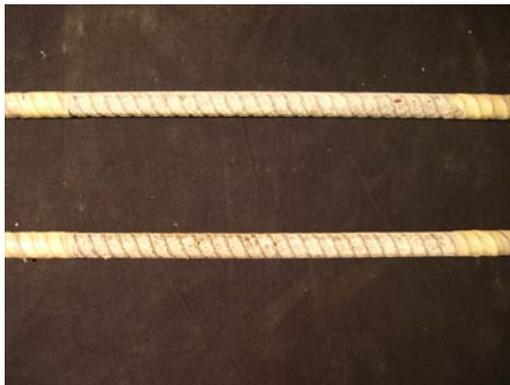
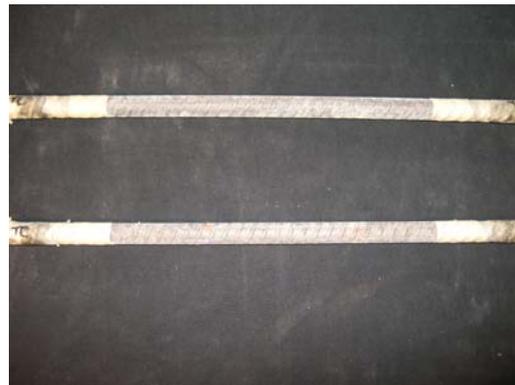
Figure 7.99 - Bars, bottom

DCI4 #8 – The visual inspection does not show any major flaws on the outside. Both bars had corrosion on the tops and bottoms. The corrosion was either spots or not well concentrated. The half cell potential values all fell into the 10% probability range. The voltage data showed that the specimen had not failed. The inspection concluded the corrosion to be minor.

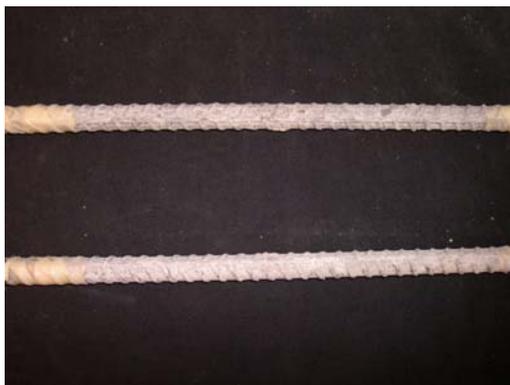
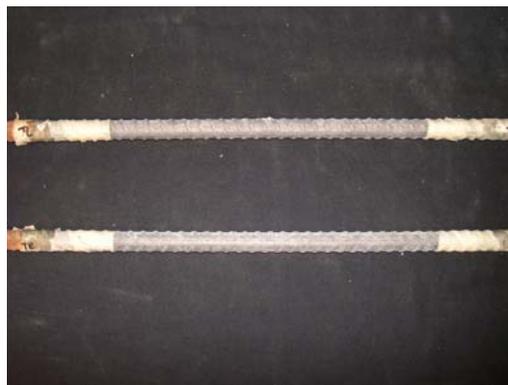
Figure 7.103 - Bars, bottom

DCI5 #8 – The top surface showed some light discoloration on the right side. There was very little corrosion on the inside. There were only a few spots on the bottom of the left bar. The half cell potential values all fell into the 10% probability range. The voltage numbers indicated that the specimen had not failed. The inspection concluded the corrosion to be none.

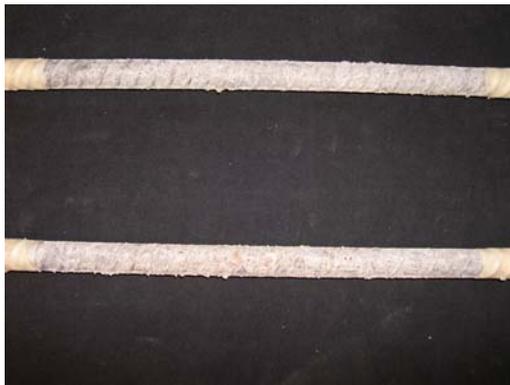
Figure 7.107 - Bars, bottom

DCI6 #8 – The specimen from the outside looked in fair condition. The majority of corrosion occurred on the bottom of the right bar. The corrosion was scattered over a large area. There were also some spots on the top of the right bar. The half cell potential values all fell into the 10% probability range. The voltage data showed the specimen did not meet the failure criteria. The inspection concluded the corrosion to be minor.

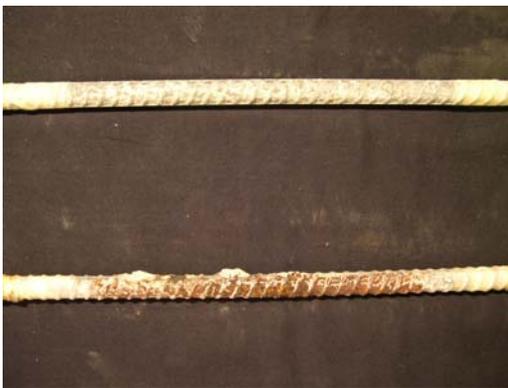
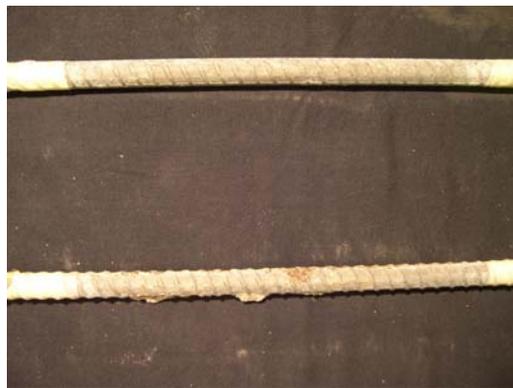
Figure 7.111 - Bars, bottom

FA5 #1 – The visual inspection showed a crack on the top surface above the right bar. There were also many cracks underneath the epoxy coating on the right side. Inside the specimen the majority of the corrosion occurred on the bottom of the right bar. There were two large areas of corrosion on the top of the right bar. The left bar had a few pits and spots on the bottom. The half cell potential values indicated 90% probability of corrosion. The voltage readings showed the specimen had failed. The inspection concluded the corrosion to be moderate to significant.

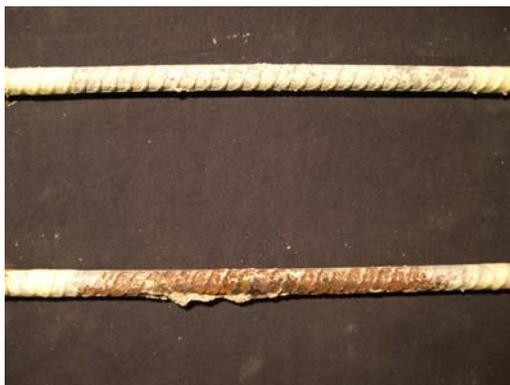
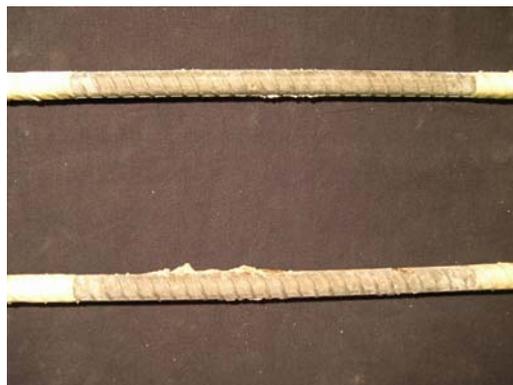
Figure 7.115 - Bars, bottom

FA5 #2 – The visual inspection from the outside showed no flaws. The inside showed the bottom of the right bar covered in corrosion. There were pits of corrosion scattered along the bottom of the left bar. The half cell potential testing showed that all the values fell into the uncertain range. The voltage readings indicated that the specimen was half way toward failure. The inspection concluded the corrosion to be moderate to significant.

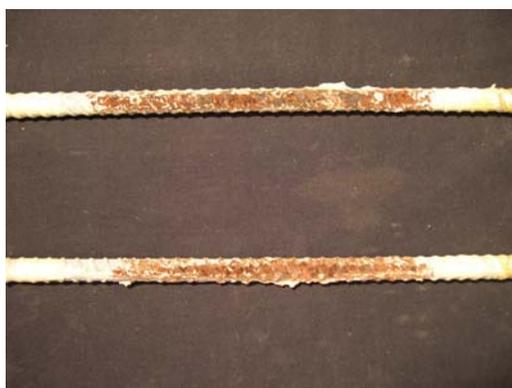
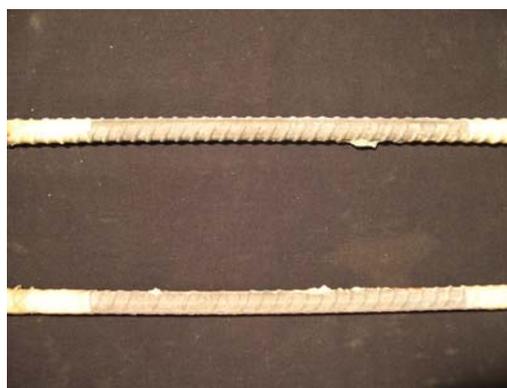
Figure 7.119 - Bars, bottom

FA5 #3 – The visual inspection did not show any critical flaws of the specimen. Both bars were covered in corrosion on the bottom over the length of the bars. The tops of both bars have scattered spots in a few areas. The half cell potential values showed that all the values fell into the 10% probability of corrosion range. The voltage readings indicated the specimen was extremely close to failure. The inspection concluded the corrosion to be moderate to significant.

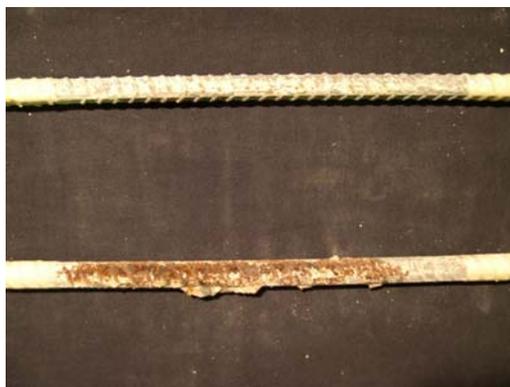
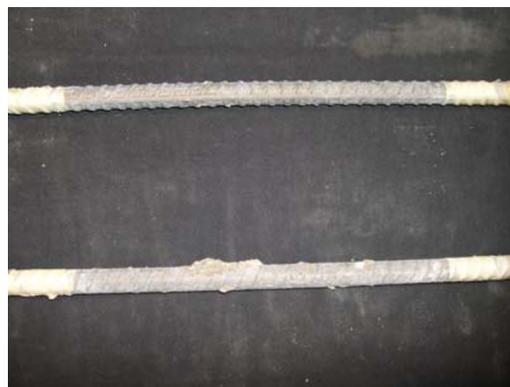
Figure 7.123 - Bars, bottom

FA5 #4 – The visual inspection of the outside of the specimen showed that the specimen was in good condition. The right bar was covered in corrosion along the bottom of the bar. The left bar also had pits along the bottom. The half cell potential test showed that all the values fell into the uncertain range. The voltage readings showed that the specimen had not reached failure. The inspection concluded the corrosion to be moderate to significant.

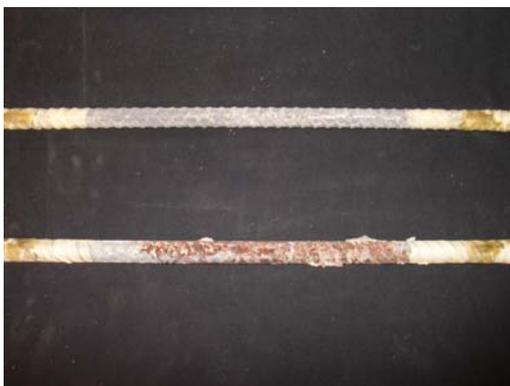
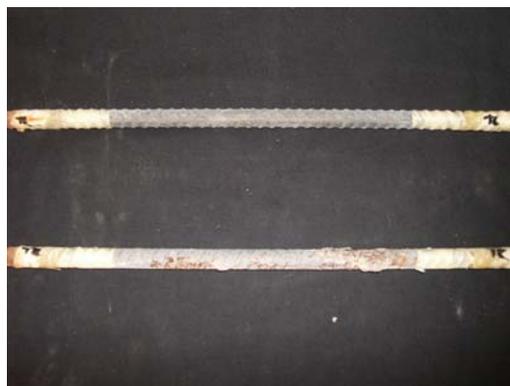
Figure 7.127 - Bars, bottom

FA6 #3 – The top surface looked uneven but no major flaws. The right bar was covered in corrosion for the majority of the bottom of the bar. The top of the bar had a few concentrated areas of corrosion. The left bar had some spots along the bottom of the bar. The half cell potential readings showed all of the values fell into the uncertain range. The voltage readings indicated that the specimen had failed. The inspection concluded the corrosion to be moderate to significant.

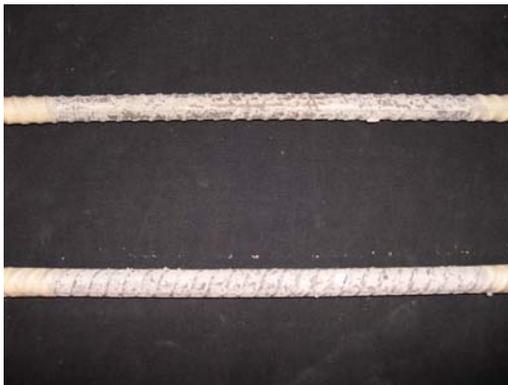
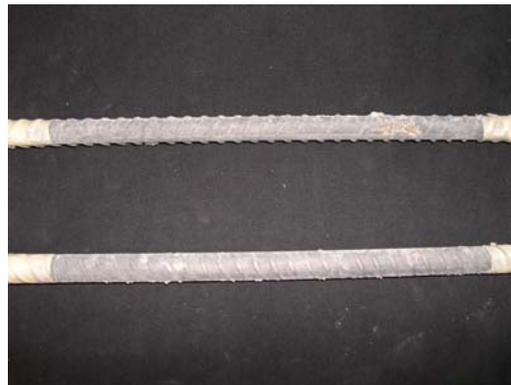
Figure 7.131 - Bars, bottom

FA9 #3 – The visual inspection did not reveal any serious problems. There was very little corrosion located on the bars. Both bars had a small area of spotted corrosion. The half cell testing indicated that all the values fell into the 10% probability range. The voltage readings showed that the specimen had not failed. The inspection concluded the corrosion to be minor.

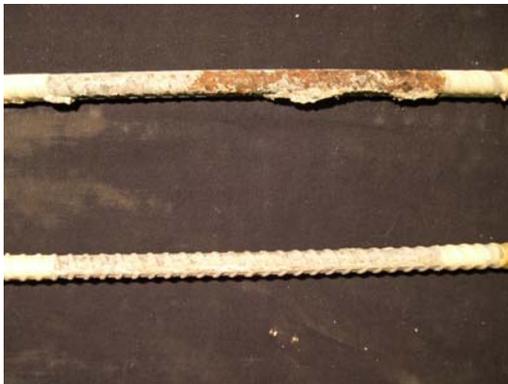
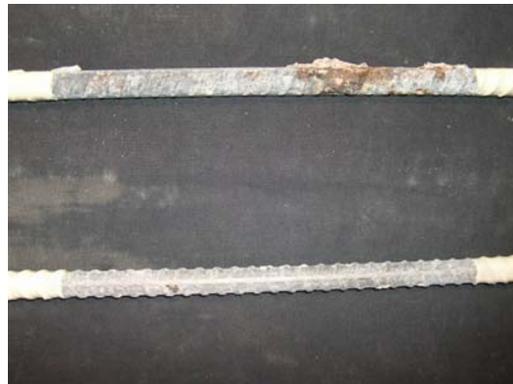
Figure 7.135 - Bars, bottom

FA10* #2 – There are three cracks located on the top surface above the left bar. The left bar was covered in corrosion on the bottom for most of the bar. The top of the left bar had a large concentrated area of corrosion. The right bar had a few spot here and there. The half cell potential values showed that two values on the right and left side fell into the 90% probability range. The other two values left fell into the uncertain range. The voltage readings showed the specimen has failed. The inspection concluded the corrosion to be moderate to significant.

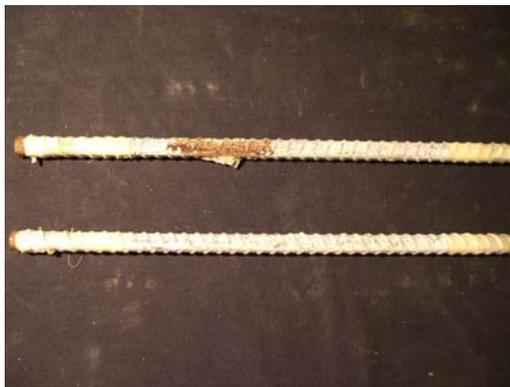
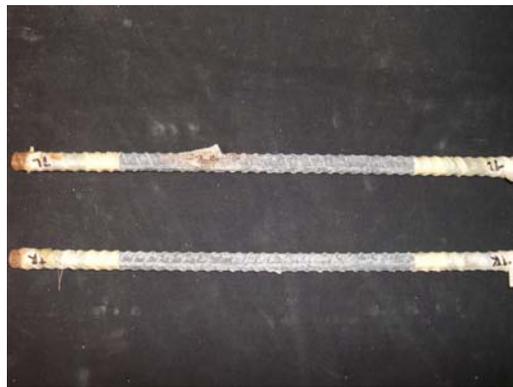
Figure 7.139 - Bars, bottom

Ferr1 #8 – The visual inspection showed a tiny crack on the edge of the top surface on the left side. The left bar had corrosion on the top and the bottom of the bar. The half cell potential values all fell into the 10% probability range. The voltage results showed that the specimen had failed. The inspection concluded the corrosion to be moderate to significant.

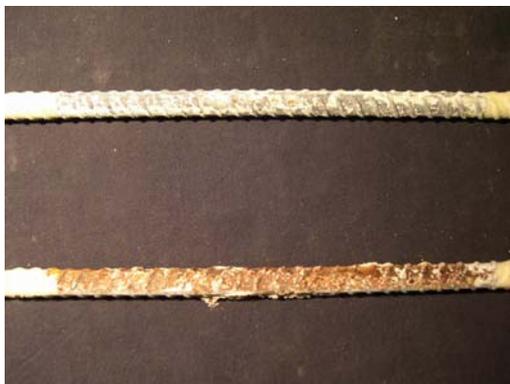
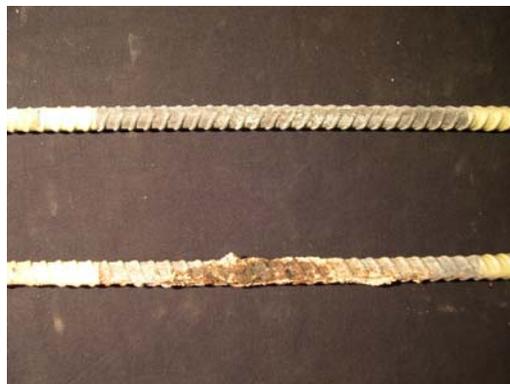
Figure 7.143 - Bars, bottom

Ferr2 #5 – The visual inspection showed a large crack along the right side of the specimen. Around the crack there was brown discoloration. There was a few cracks on the right side of the specimen. The right bar was completely covered in corrosion on the bottom. The top of the bar also has a large area of corrosion. The bottom of the left bar has a few pits. The half cell potential numbers showed all the values fell in the uncertain range. The voltage readings indicated that the specimen had failed. The inspection concluded the corrosion to be moderate to significant.

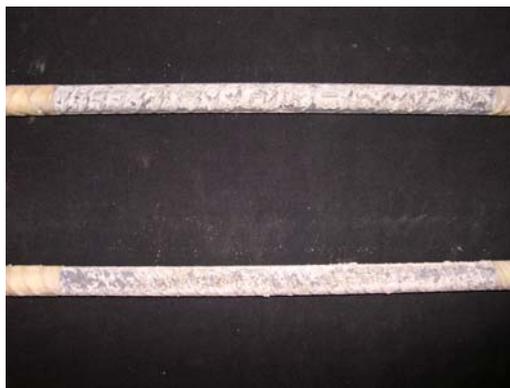
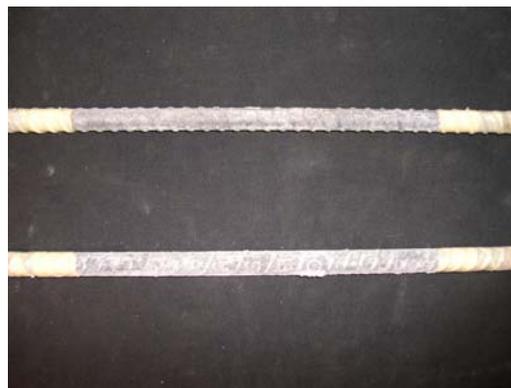
Figure 7.147 - Bars, bottom

Ferr2 #8 – The outside of the specimen looked to be in excellent condition. There was no corrosion on the inside of the specimen. The half cell potential numbers were in the 10% probability range. The voltage readings showed that the specimen was not close to failure. The inspection concluded the corrosion to be none.

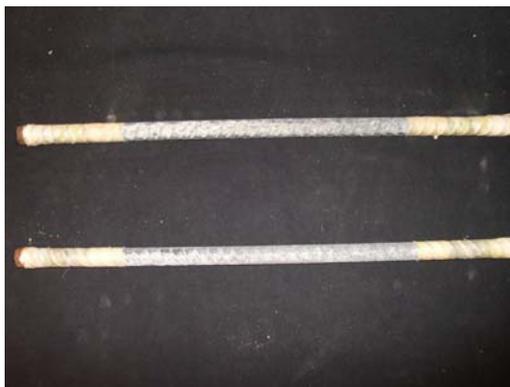
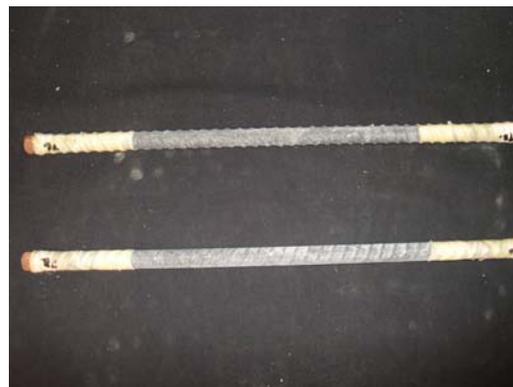
Figure 7.151 - Bars, bottom

Ferr3 #8 – The visual showed no flaws of significance on the outside of the specimen. The inside of the specimen was clean. The half cell potential values were all in the 10% probability range. The voltage readings showed that the specimen was not near failure. The inspection concluded the corrosion to be none.

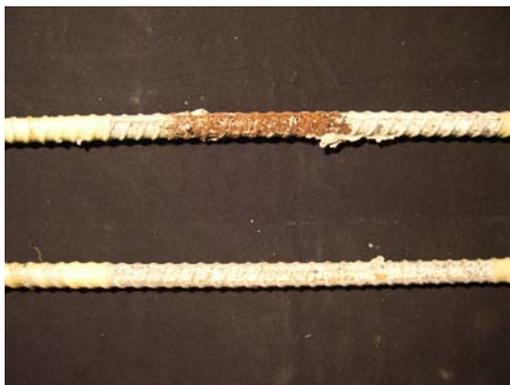
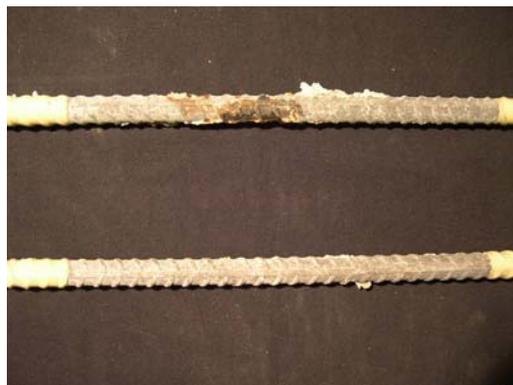
Figure 7.155 - Bars, bottom

Ferr4 #1 – The outside of the specimen looked to be in great condition. The left bar had corrosion toward the front of the bar on both the top and the bottom. The right bar had pits and spots along the length of the bottom. The half cell potential readings fell into the uncertain region. The voltage readings showed that the specimen had failed. The inspection concluded the corrosion to be moderate to significant.
